Re: Notice of Intent to Sue for Violations of General NPDES Permit No. ALR10A872 and Ala. Admin. Code Ch. 335-6-12

# A. Failure to Stabilize Woodley Road Entrance/Exit

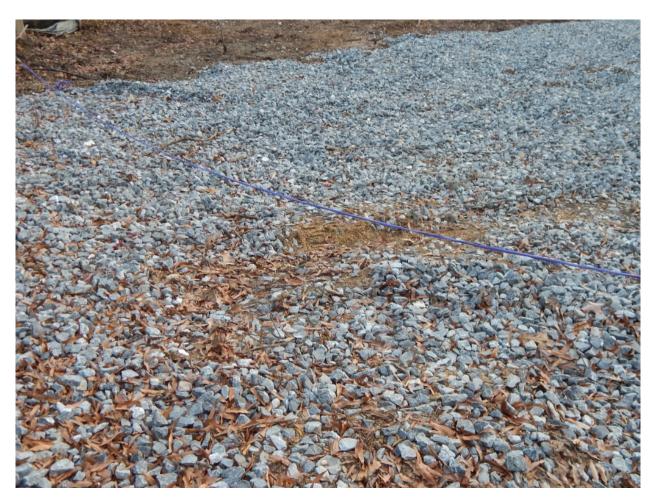
The gravel used at the Woodley Road entrance/exit to the site is not eight (8) inches in depth for the entire length of the entrance as represented by the engineer. This entrance/exit has not been adequately stabilized to prevent erosion caused by vehicular and equipment traffic and to minimize off-site tracking of sediment in violation of General NPDES Permit No. ALR10A872, Part III. A. 8. Exhibits D-1, D-2. This violation has continued every day since October 9, 2013.

Failure to Stabilize Woodley Road Entrance/Exit 12.26.2013

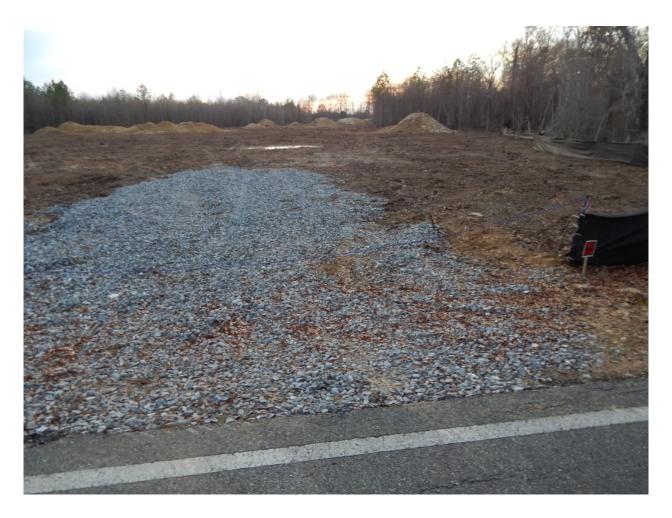
Failure to Stabilize Woodley Road Entrance/Exit 12.26.2013

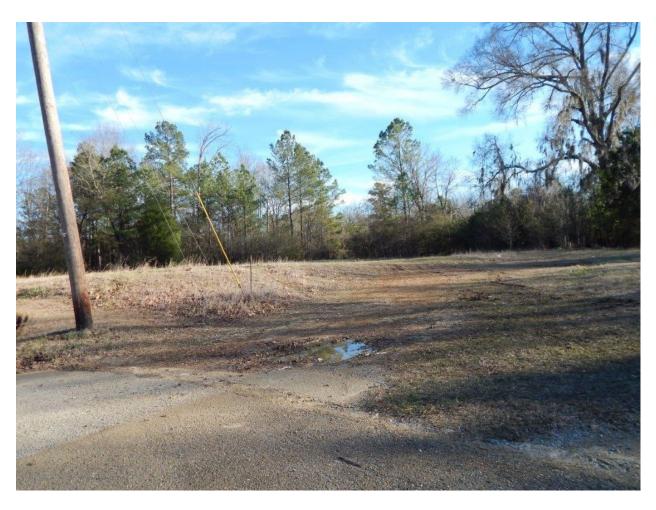
The Andova Drive entrance/exit to the site was used to transport heavy equipment to the site in mid-September, 2013 and has since been used by site workers and their vehicles. The entrance/exit has not been adequately stabilized to prevent erosion and to minimize off-site tracking of sediment in violation of General NPDES Permit No. ALR10A872, Part III. A. 8. Exhibits D-3, D-4, D-5. This violation has continued every day since September 16, 2013.

Failure to Stabilize Andova Drive Entrance/Exit 11.18.2013

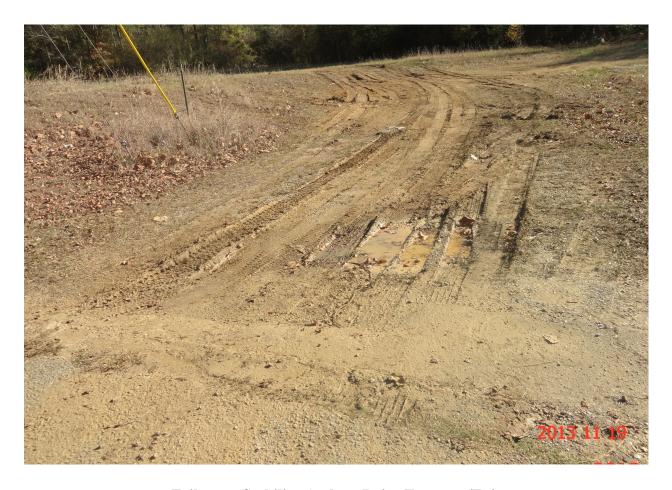
Failure to Stabilize Andova Drive Entrance/Exit 11.19.2013

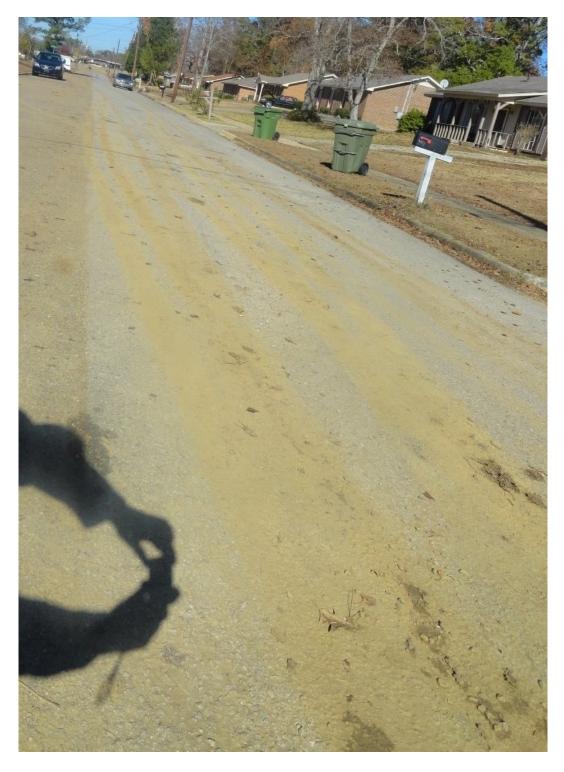
Sediment Tracking on Andova Drive 11.18.2013

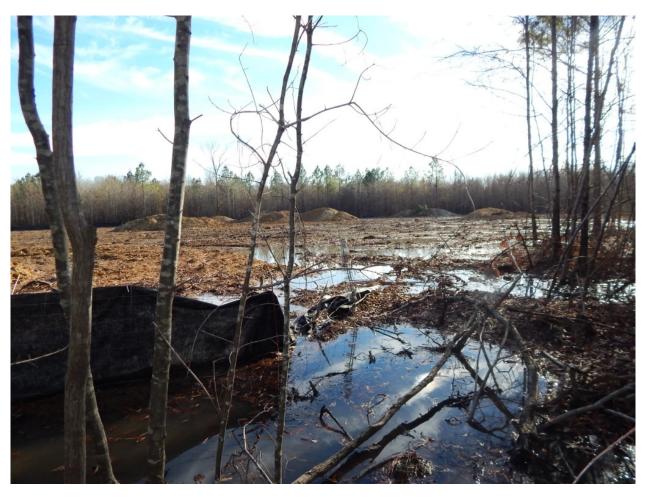
Silt fencing or other appropriate sediment control measures to minimize sediment discharges from the site have not been implemented or installed on the entire north perimeter of the site in violation of General NPDES Permit No. ALR10A872, Part III. D. 2. and Part III. A. 5. Exhibit D-6. This violation has continued every day since December 19, 2013.

Failure to Implement/Install Sediment Control Measures 1.3.2014

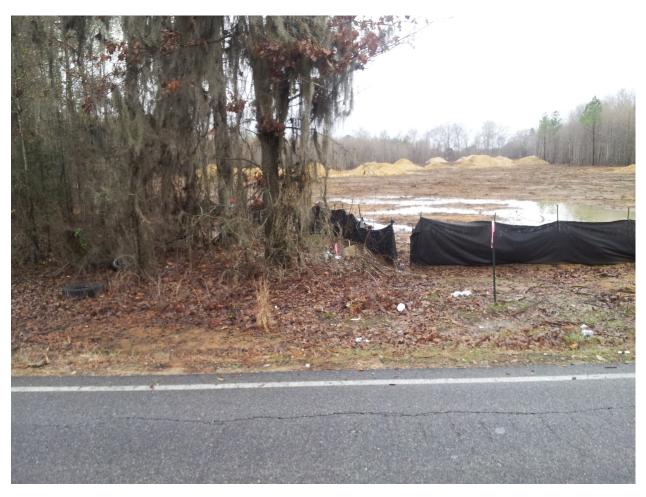
Silt fences on the north side and south side of the Woodley Road entrance have not been properly maintained and are in disrepair in violation of General NPDES Permit No. ALR10A872, Part III. D. 2. and Part III. A. 5. Exhibits D-7, D-8, D-9, D-10, D-11. This violation has continued every day since December 19, 2013.

Failure to Maintain Silt Fences 12.23.2013

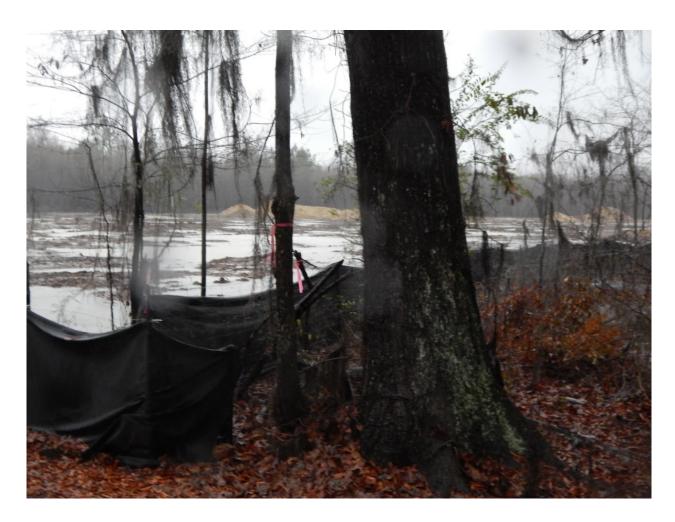
Failure to Maintain Silt Fences 12.28.2013

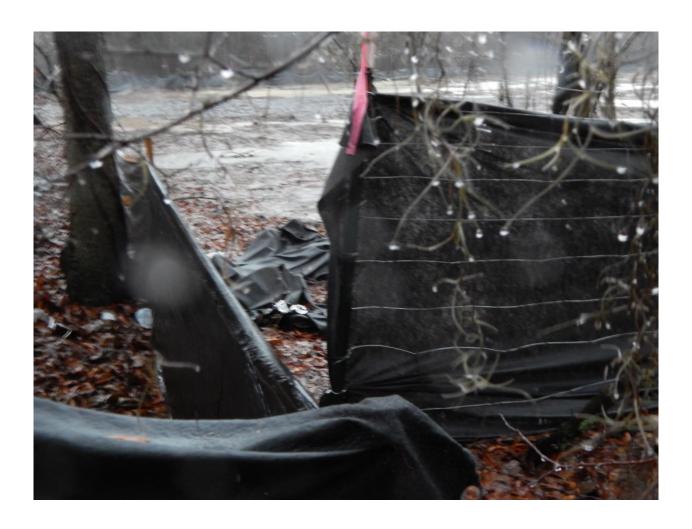
Failure to Maintain Silt Fences 12.28.2013

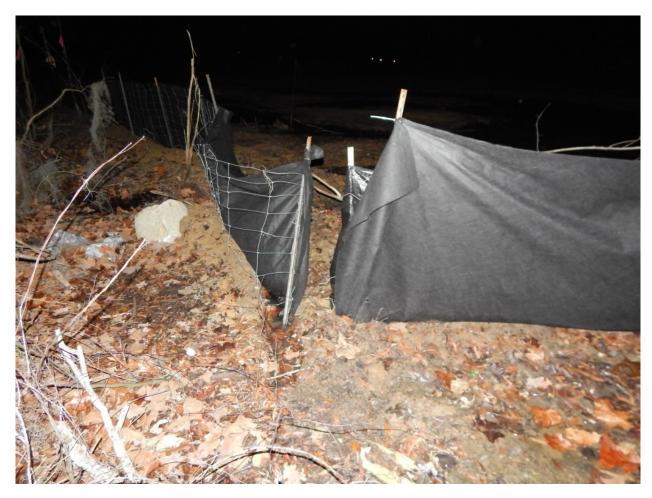
Failure to Maintain Silt Fences 1.2.2014

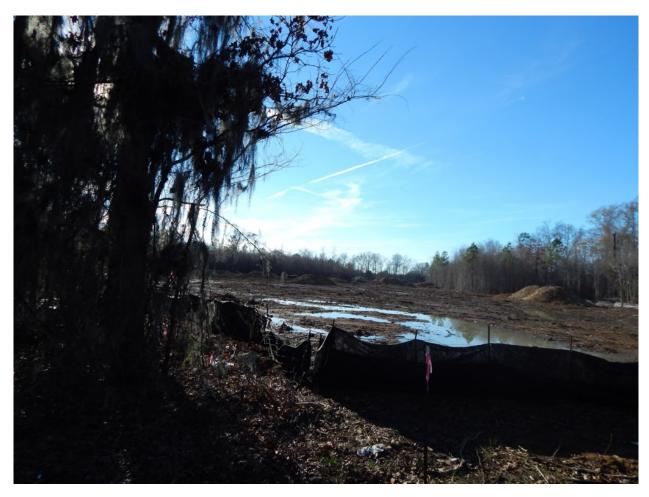
Failure to Maintain Silt Fences 1.3.2014

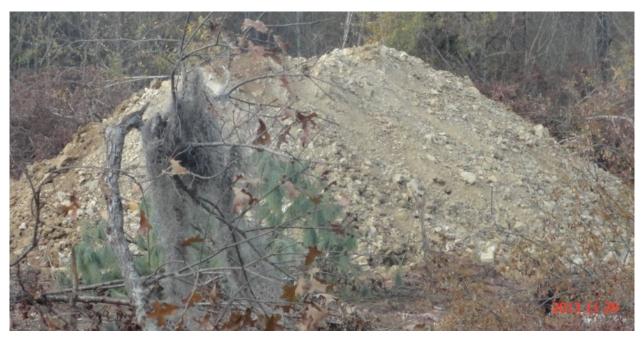
Work toward project completion and final stabilization at the site has temporarily ceased for at least thirteen (13) days. Temporary stabilization of exposed soils, including multiple dirt piles, has not been implemented in violation of General NPDES Permit No. ALR10A872, Part III. A. and Part III. B. Exhibits D-12, D-13, D-14, D-14, D-16, D-17, D-18, D-19. This violation has continued every day since December 24, 2013

Failure to Provide Temporary Stabilization 11.20.2013

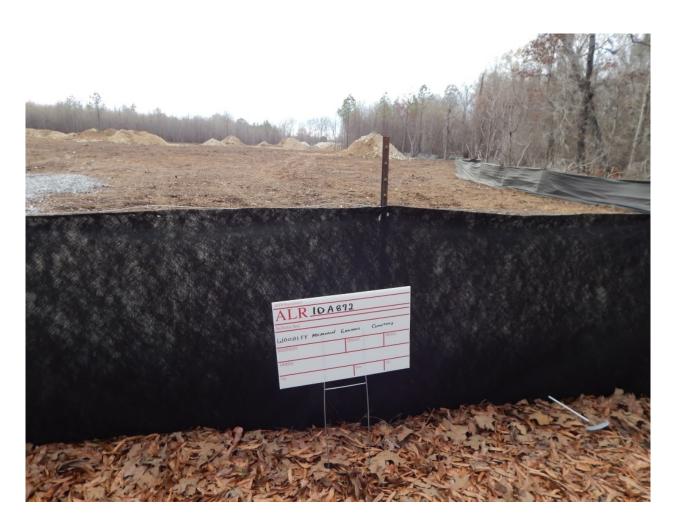
Failure to Provide Temporary Stabilization 12.21.2013

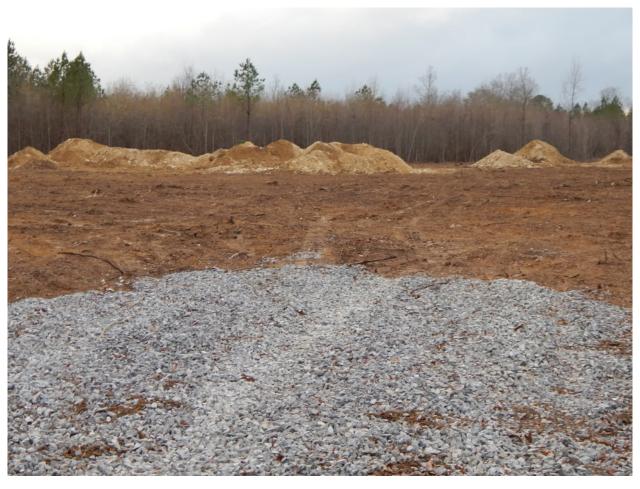
Failure to Provide Temporary Stabilization 12.21.2013

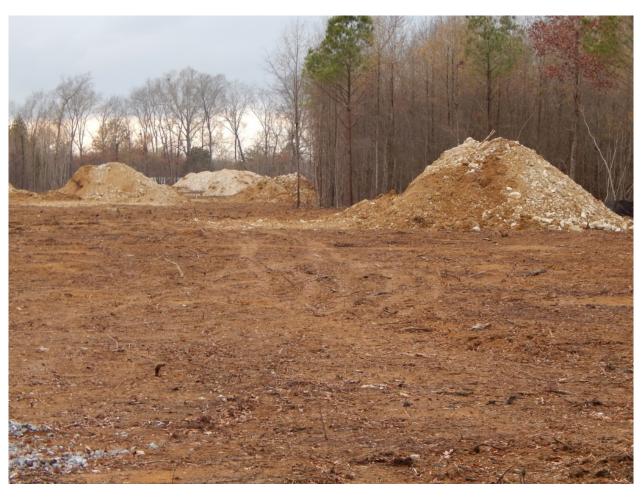
Failure to Provide Temporary Stabilization 12.21.2013

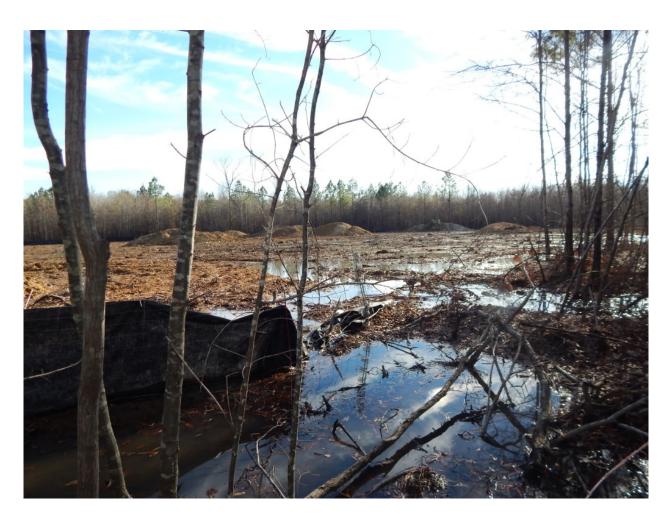
Failure to Provide Temporary Stabilization 1.3.2014

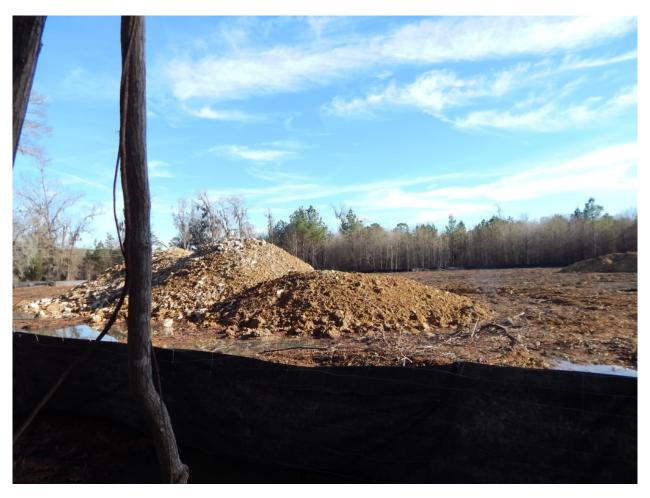
Failure to Provide Temporary Stabilization 1.3.2014

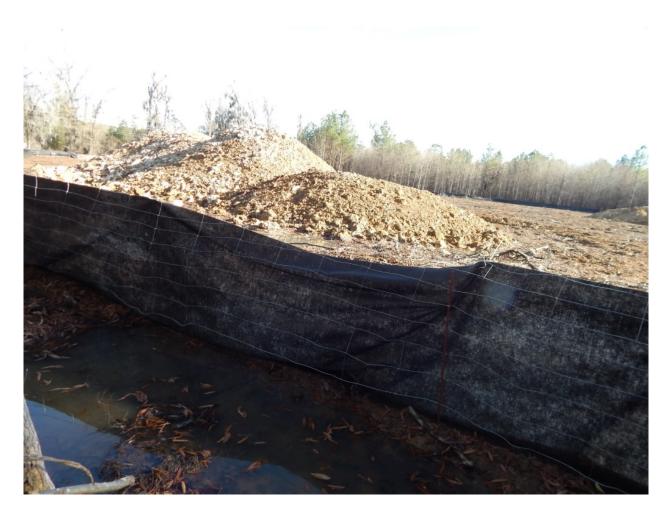
Failure to Provide Temporary Stabilization 1.3.2014

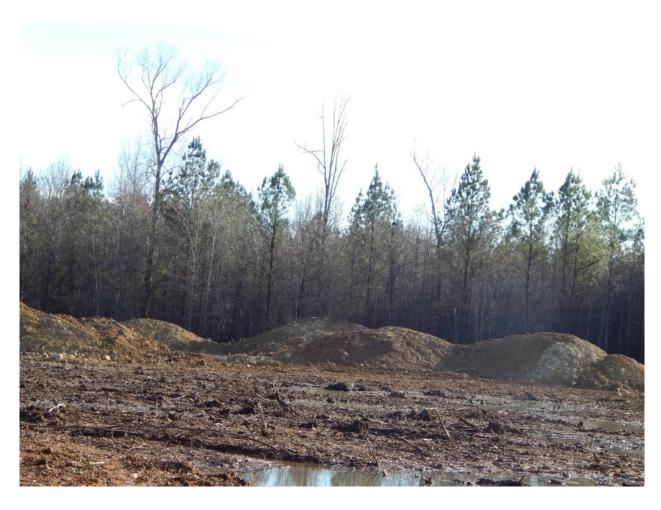
Failure to Provide Temporary Stabilization 1.3.2014

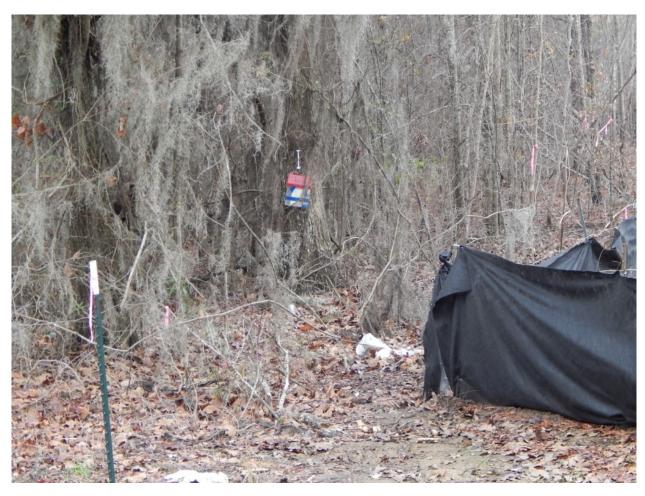
The Permittee attached a rain gauge to the trunk of a tree. Rainfall is obstructed by branches, a leafy canopy and Spanish moss. Precipitation measurements are not representative of the rainfall

on the construction site in violation of General NPDES Permit No. ALR10A872, Part III. J. Exhibits D-20, D-21. This violation has continued every day since December 3, 2013.

Improper Rain Gauge Placement 12.23.2013

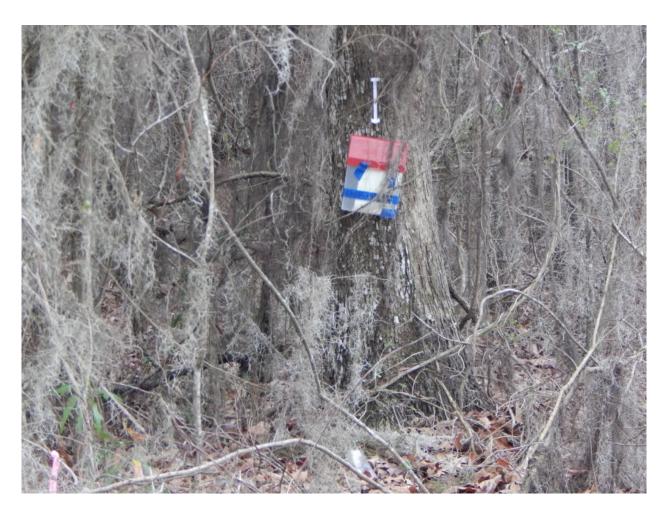
Improper Rain Gauge Placement 12.23.2013

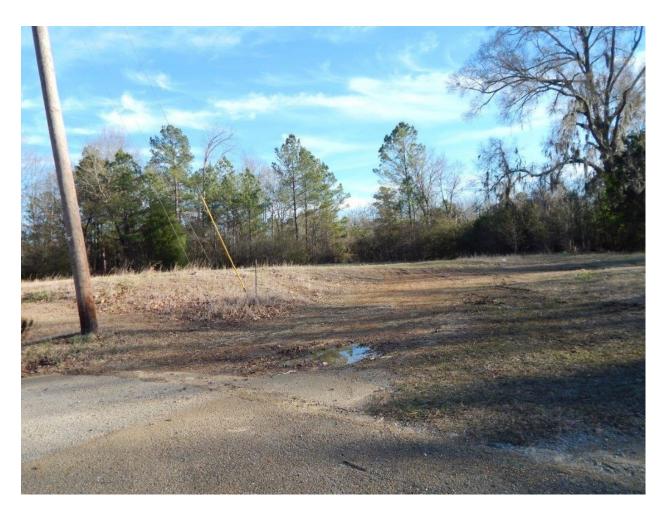
The Notice of Intent (NOI) on which General NPDES Permit No. ALR10A872 is based indicates that the total disturbed area will be 8.8 acres. This acreage reflects only the proposed cemetery and Woodley Road entrance/exit. It does not reflect the Andova Drive entrance/exit which extends from the southern terminus of Andova Drive in an easterly direction and thence northward to the permitted site of Woodley Memorial Gardens. Exhibit D-24. This entrance/exit has been used by heavy equipment and site workers to access the permitted site. Xavier D. Harris has engaged in and continues to engage in regulated construction activity that has resulted in land disturbance along the Andova Drive entrance/exit in violation of Ala. Admin. Code rs. 335-6-12-.05(1) and 335-6-12-.11(1). Exhibits D-22, D-23. This violation has continued every day since September 16, 2013.

Disturbance Outside Permitted Area 11.18.2013

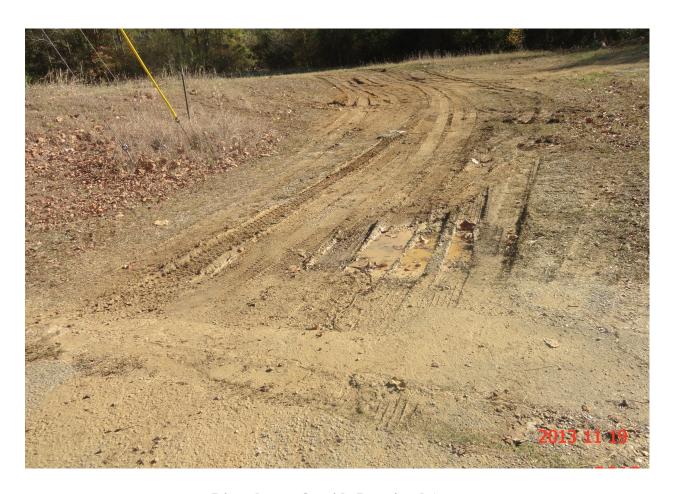
Disturbance Outside Permitted Area 11.18.2013

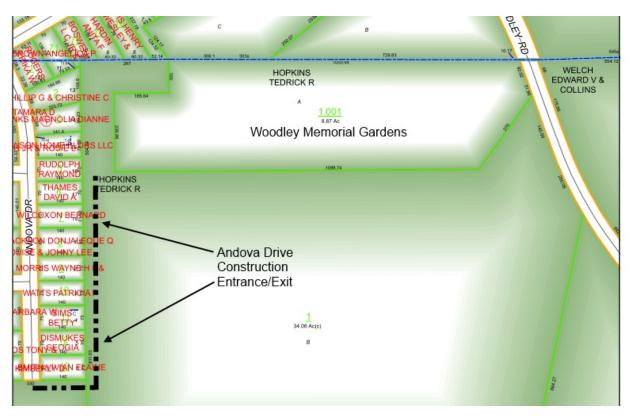
Disturbance Outside Permitted Area Andova Drive Construction Entrance/Exit
